EXTERNAL SYNC INPUT IMPEDANCE EFFECT

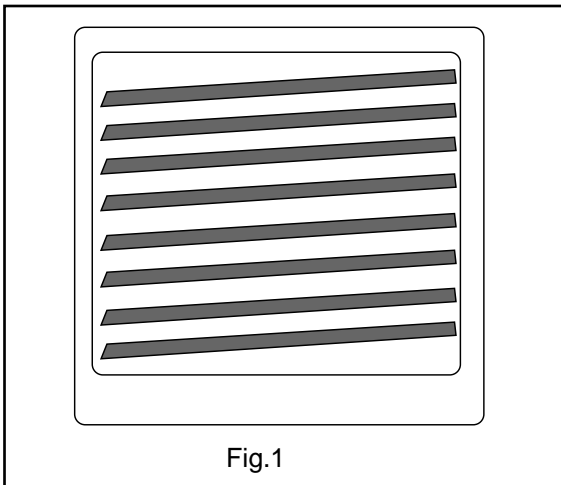
Recently we observed an external sync problem related to the input impedance of PULNiX cameras. The problem was that some cameras would not sync to a vision system's horizontal sync and the resulting picture on the display was dozens of horizontal bars (Figure 1).

This is a typical characteristic of video when the horizontal frequency is higher than the monitor's capture range. The problem turned out to be a subtle variation in the pulse edge which would not show up during routine factory testing.

By reducing input impedance at the camera input, such pulses can be suppressed and potential noises can be eliminated from running cables.

Since the majority of SONY CCD cameras come with 75 Ω termination, PULNiX will change the impedance spec to 75 Ω instead of 4.7K Ω . Please consult PULNiX for further information in order to optimize impedance matching.

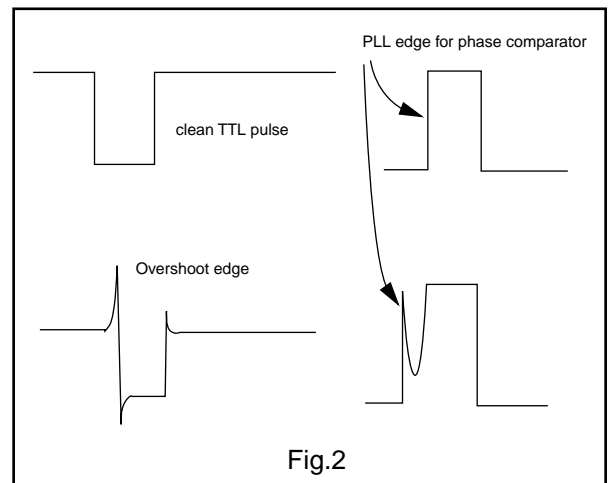
The initial investigation was done with a TM-765. The PLL (Phase Lock Loop) input inside the camera was not receiving a clean pulse due to the overshoot of the input external sync (Figure 2).

The transistor driver occasionally outputs horizontal pulses with overshoot or ringing edges. Since the PLL needs a clean edge to lock the frequency, these peaked pulses confuse the phase locking.
