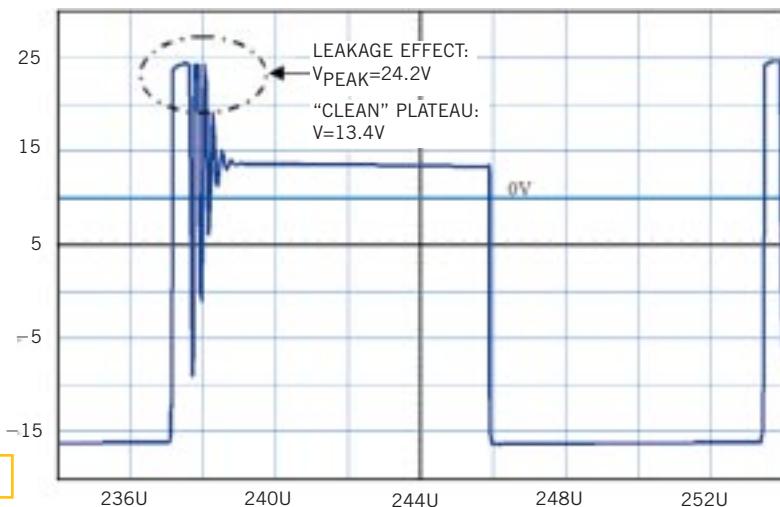
Figure 2

The leakage inductance on the auxiliary-winding side causes high rectified voltages.
